## M300 RTK Known Issue List

| Released date | 2021.03.05 |
| Aircraft Firmware: | v02.02.02.01 |

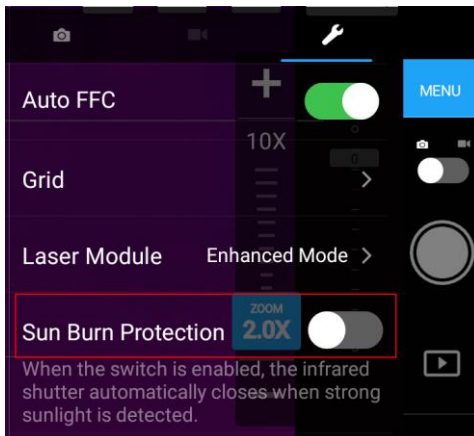
| 1. | When H20T is aimed at an object with a high temperature, the Sun Burn Protection function may be triggered, and there will be an option to allow you to disable the protection. However, after you disable it, later the Protection will still be triggered. | <p>Please disable the Sun Burn Protection function in the camera setting page.</p> |
